**PRELIMINARY GEOLOGIC AND GEOTECHNICAL
ENGINEERING INVESTIGATION**

Proposed Fifteen-Lot Subdivision

Tujunga, California

Project 2793

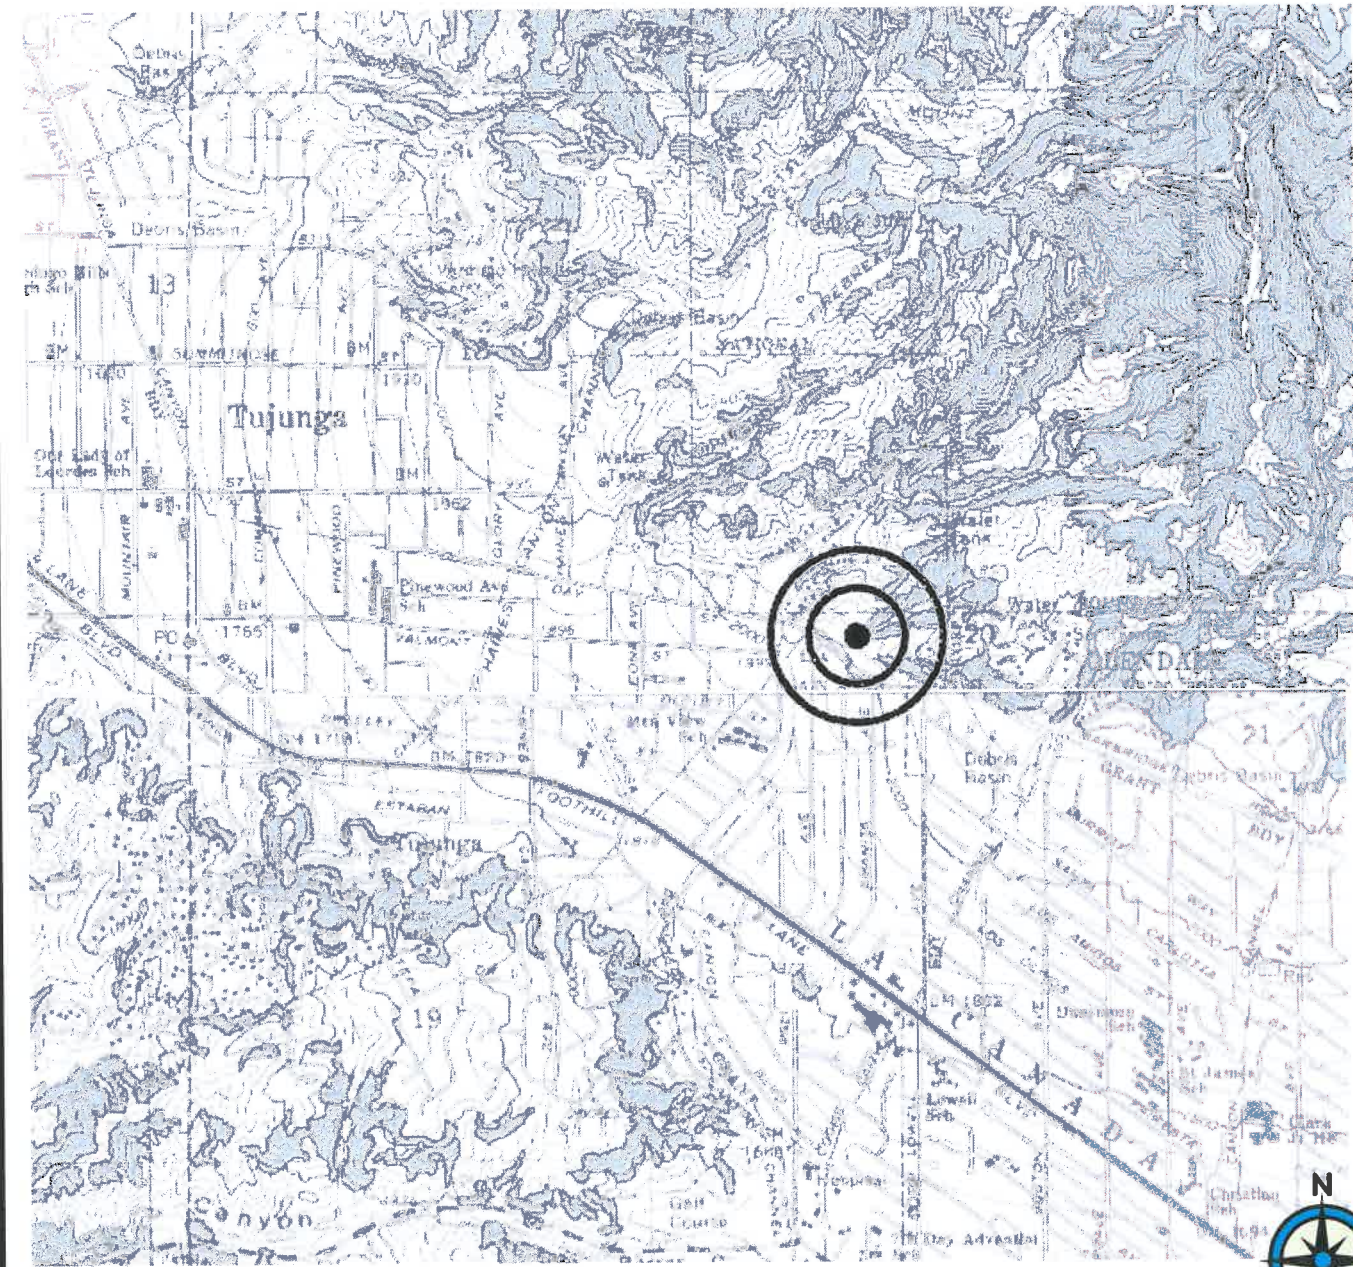
SEISMIC HAZARD MAP

Areas where previous occurrence of landslide movement, or local topographic, geological, geotechnical and subsurface water conditions indicate a potential for permanent ground displacements such that mitigation as defined in Public Resources Code Section 2693(c) would be required.

Areas where historic occurrence of liquefaction, or local geological, geotechnical and groundwater conditions indicate a potential for permanent ground displacements such that mitigation as defined in Public Resources Code Section 2693(c) would be required.

State of California, Seismic Hazard Map of the Sunland and Burbank
Quadrangles

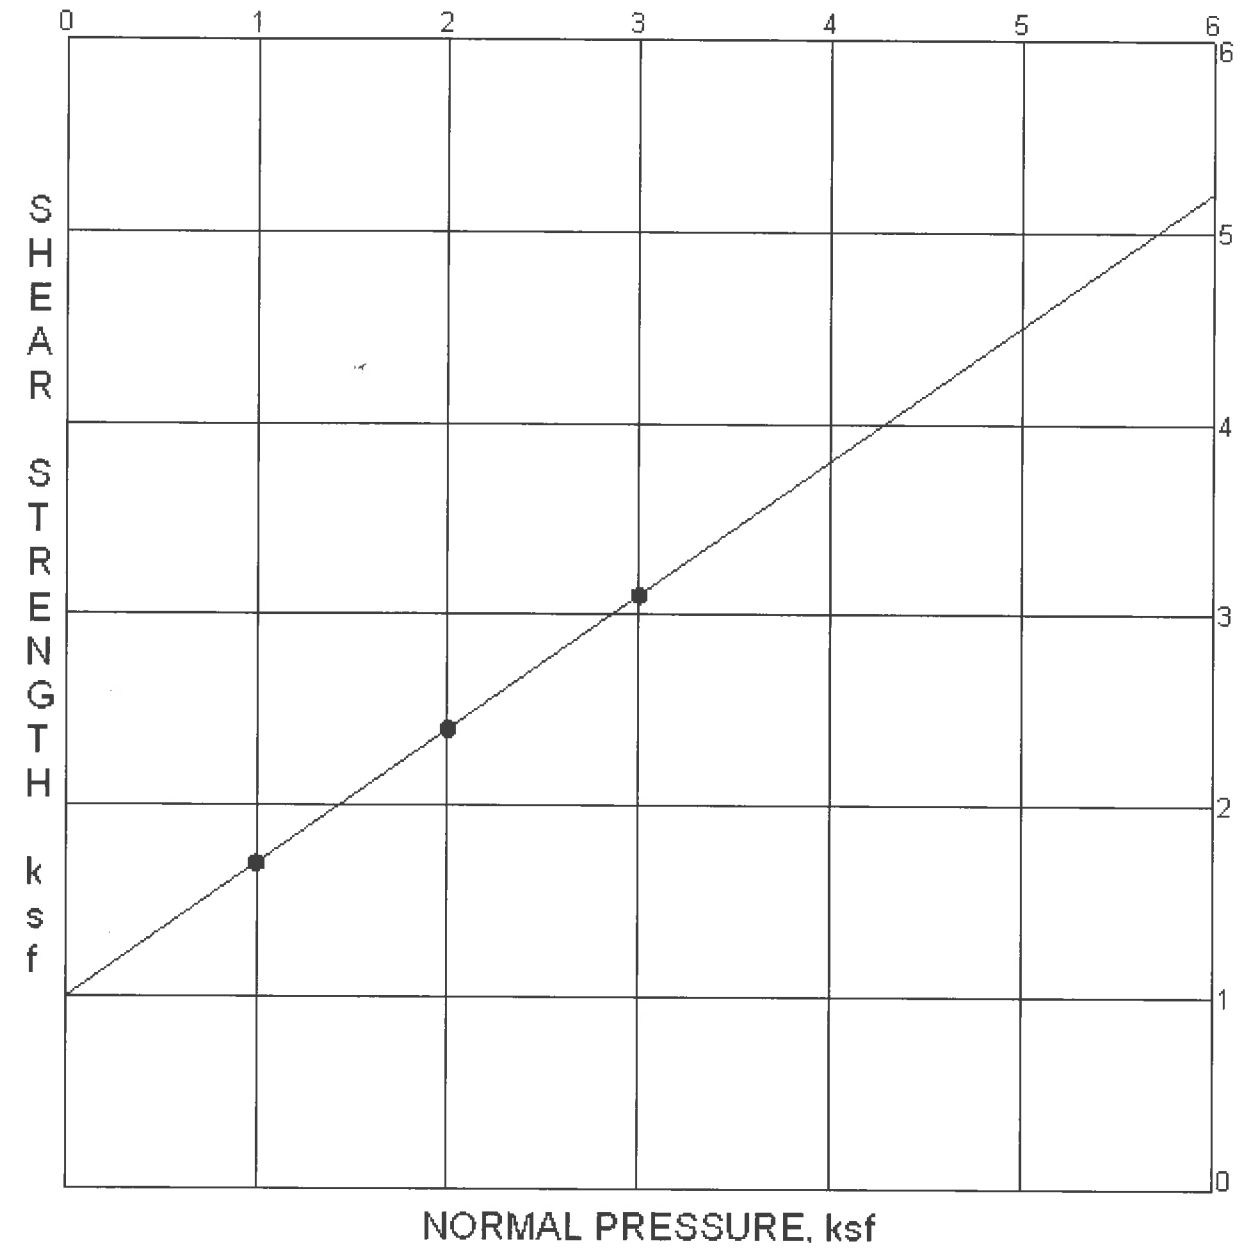
SAMPLE LOCATION: TP-D @ 5.0

Moisture Content (%)	Density (pcf)	Ultimate Strength
Insitu: 3.8 Saturated: 11.1	Dry Density: 129.5	Phi (deg): 35.0 Cohesion (ksf): 1.000

Explor -ation	Depth (ft)	Mat'l	Dry Dens. In Situ (P.C.F.)	Moisture Content (%)	Cohesion (K.S.F)	Friction Angle (degree)
TP 1	6.5	Qof ₃	106.5	12.0		
TP 1	10.0	Qof ₃	111.0	9.1		
TP 2	7.0	Qof ₃	105.3	4.1	0.200	35.0
TP 4	8.0	Qof ₁	107.7	12.4		
TP 6	6.0	Qof ₃	112.4	1.8		
TP 6	11.0	Qof ₃	109.8	5.7	0.200	33.0
TP 6	15.0	Qof ₃	110.4	6.7		
TP 6	19.0	Qof ₃	114.7	4.1		
TP-C	8.0	Qof ₂	125.1	6.6	0.250	33.0
TP-D	5.0	wd	129.5	3.8	1.000	35.0

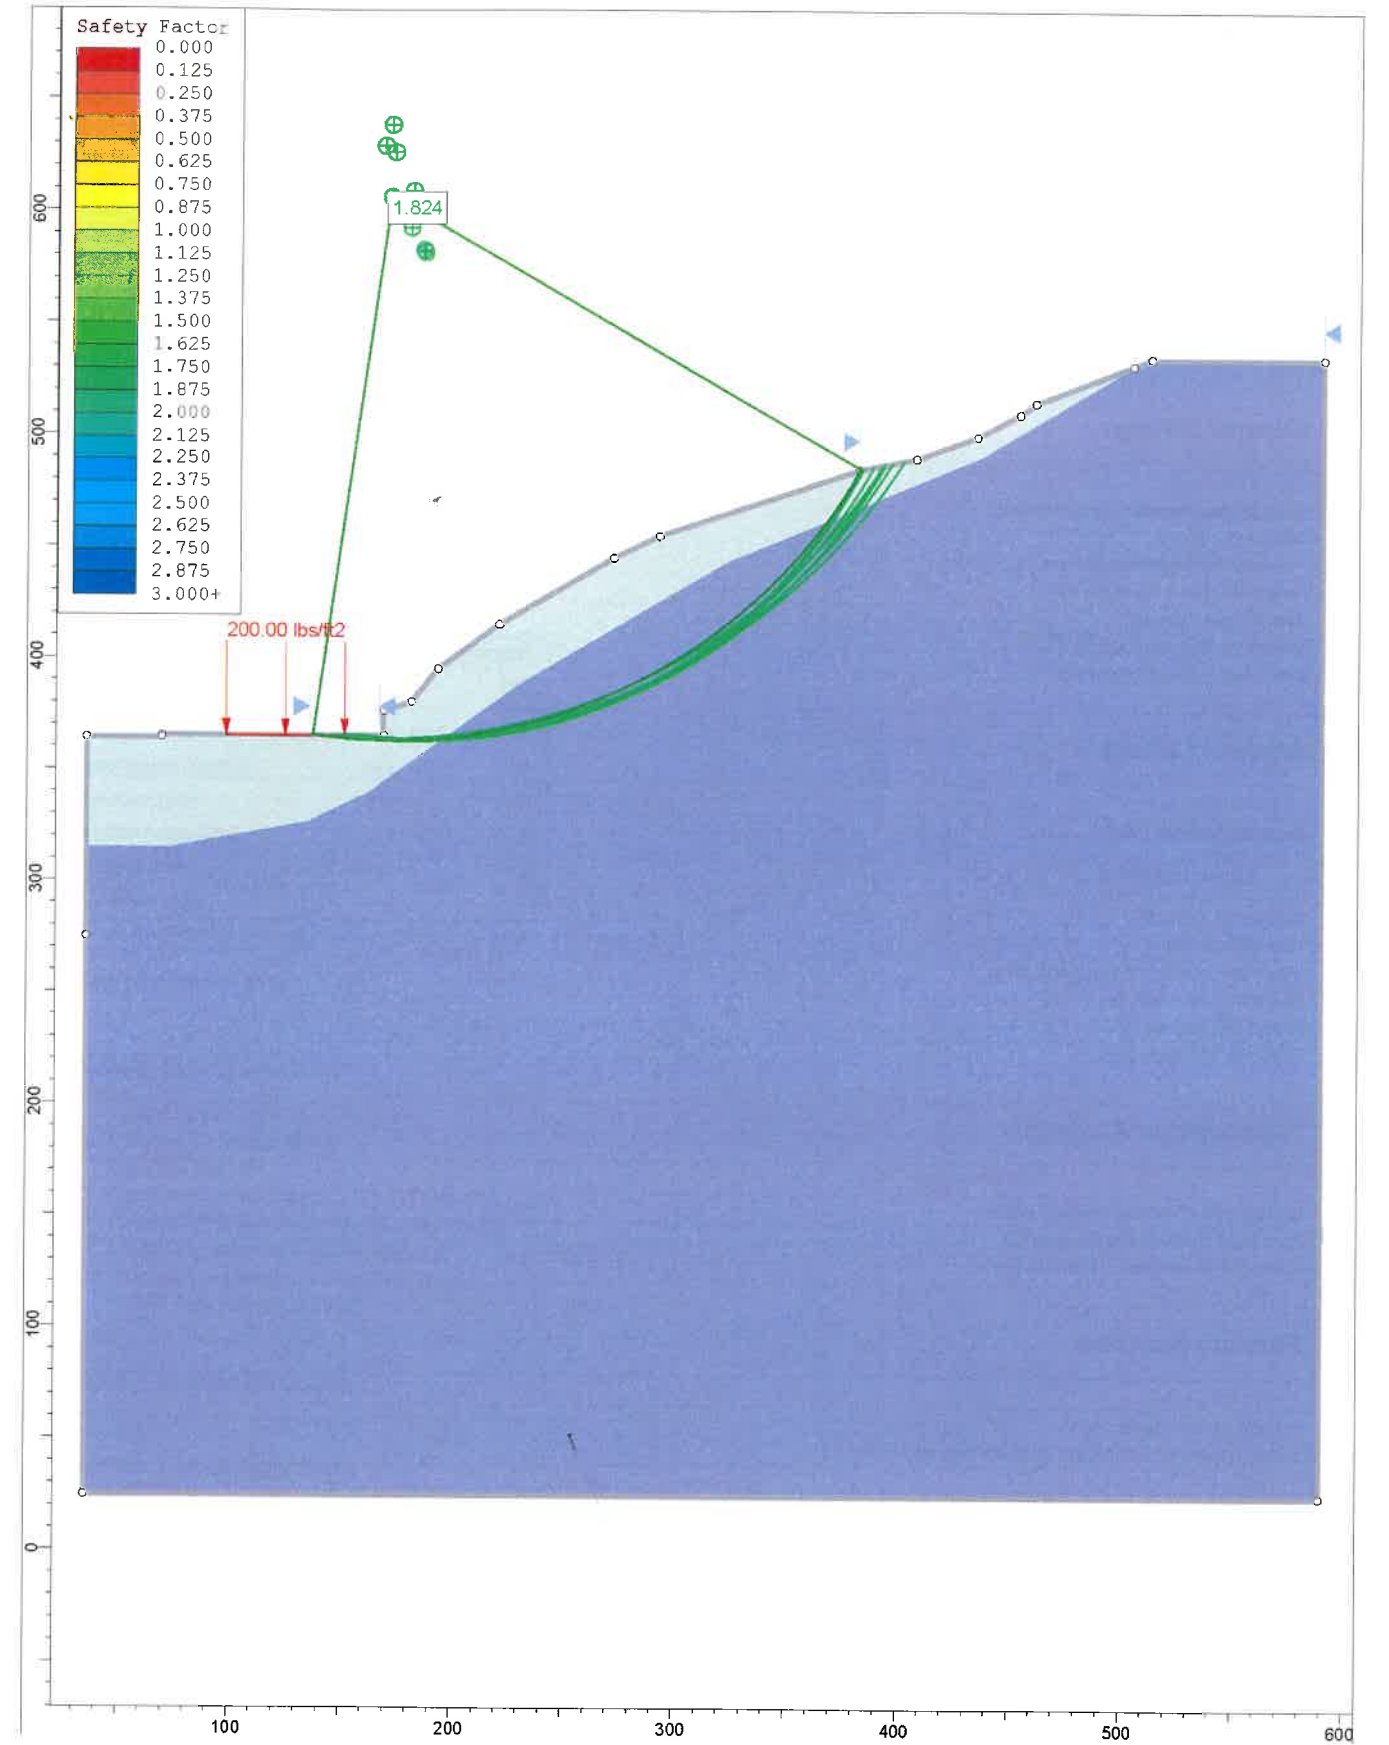
Slide Analysis Information
2793 Y-Y' Static Stability Analysis

Units of Measurement: Imperial Units
Time Units: days
Permeability Units: feet/second
Failure Direction: Right to Left
Data Output: Standard
Maximum Material Properties: 20
Maximum Support Properties: 20

Number of Surfaces: 5000
Upper Angle: Not Defined
Lower Angle: Not Defined
Composite Surfaces: Disabled
Reverse Curvature: Create Tension Crack
Minimum Elevation: Not Defined
Minimum Depth: Not Defined

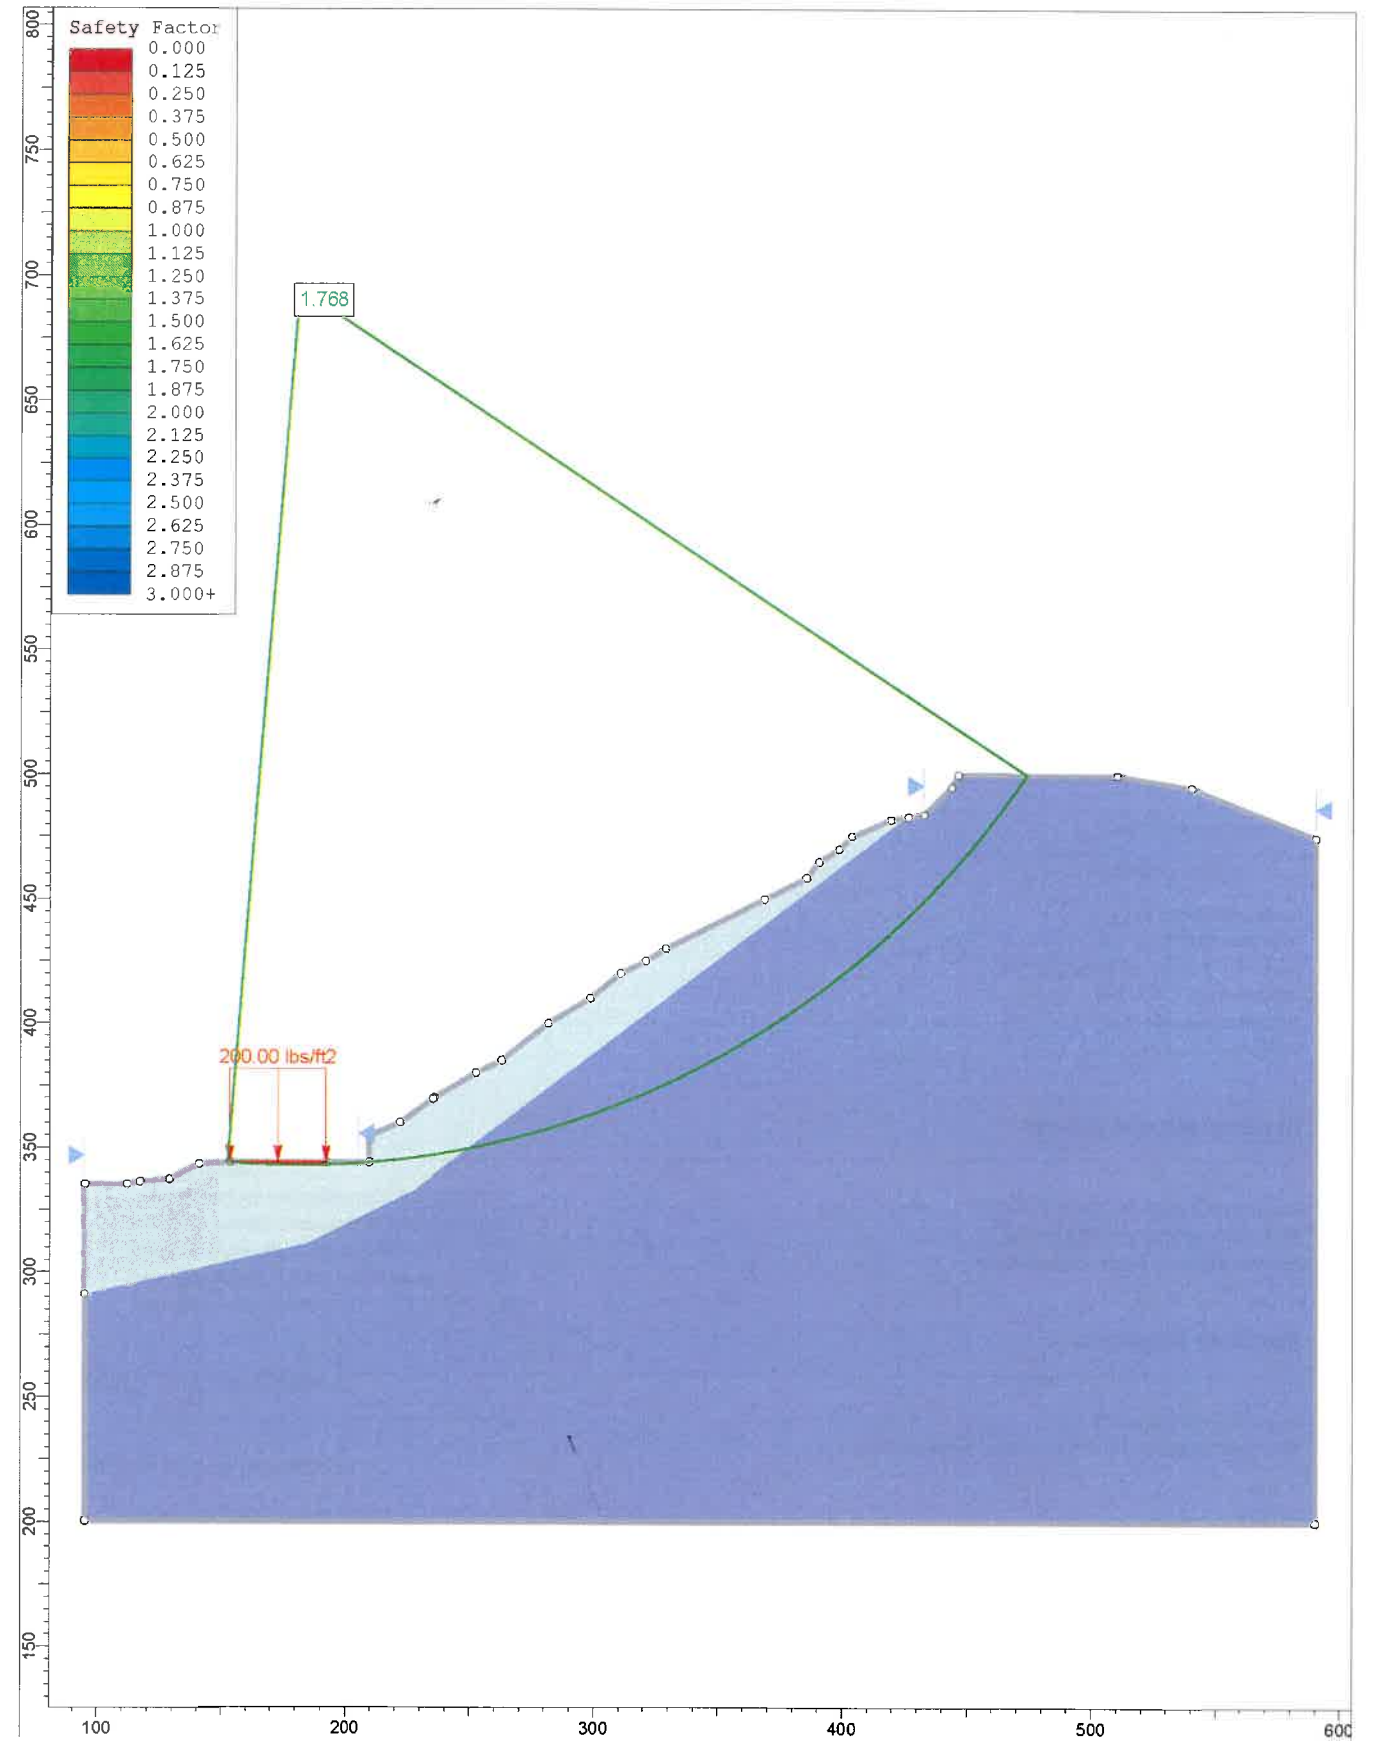
Z-Z' Slope Stability Analysis

Slide Analysis Information

Units of Measurement: Imperial Units
Time Units: days
Permeability Units: feet/second
Failure Direction: Right to Left
Data Output: Standard
Maximum Material Properties: 20
Maximum Support Properties: 20

Number of Surfaces: 5000
Upper Angle: Not Defined
Lower Angle: Not Defined
Composite Surfaces: Disabled
Reverse Curvature: Create Tension Crack
Minimum Elevation: Not Defined
Minimum Depth: Not Defined

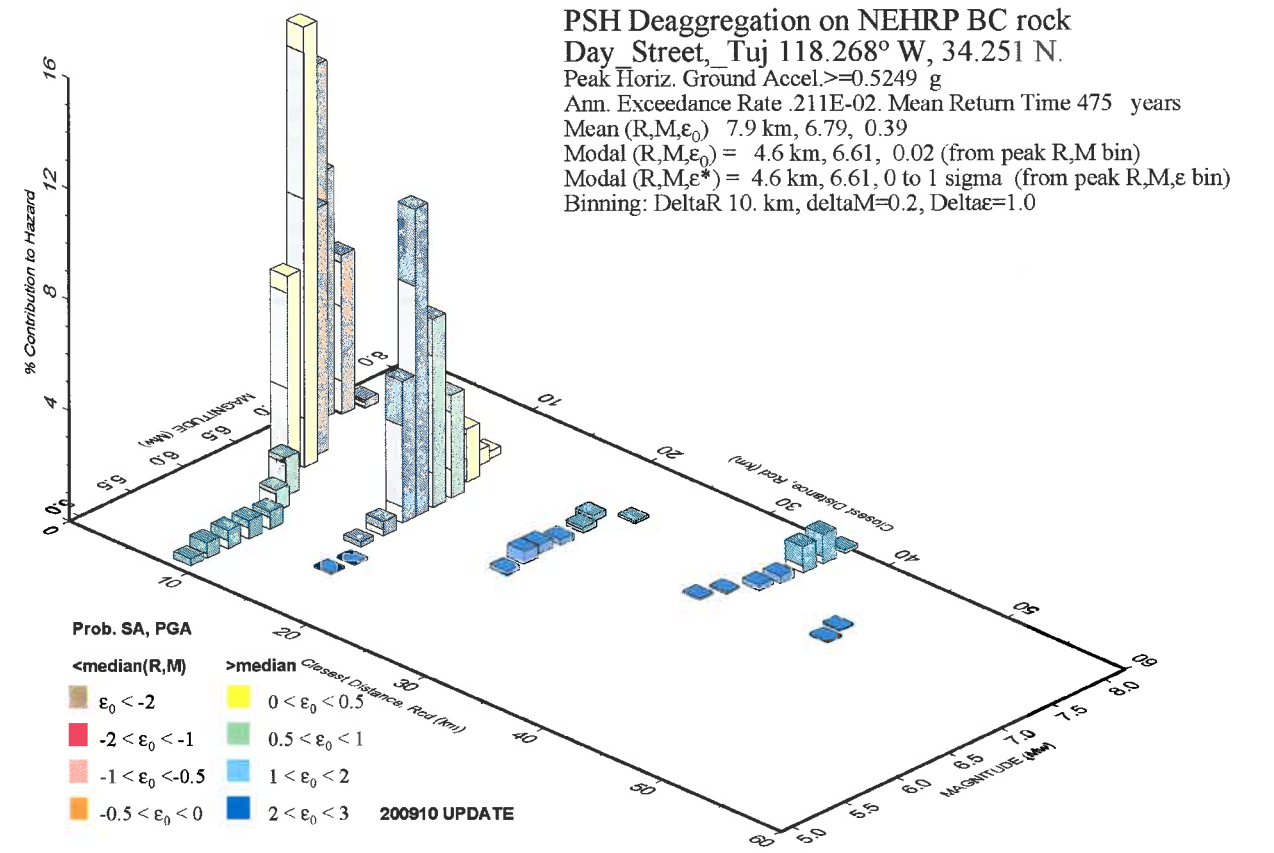
GINT 2014 Nov 17 20:35:55 Distance (R), magnitude (M), epsilon (ϵ_0) deaggregation for a site on rock with average vs= 760. m/s top 30 m. USGS CGHT PSHA2008 UPDATE Bins with 0.05% contrib. omitted
